# **CCR Rule 2025 Annual Inspection Report**

## **Morrow CCR Impoundment STS Hydropower, LLC**

**February 6, 2025**

**Attachment:**  
**STS Morrow CCR Impoundment – Annual Inspection Form**

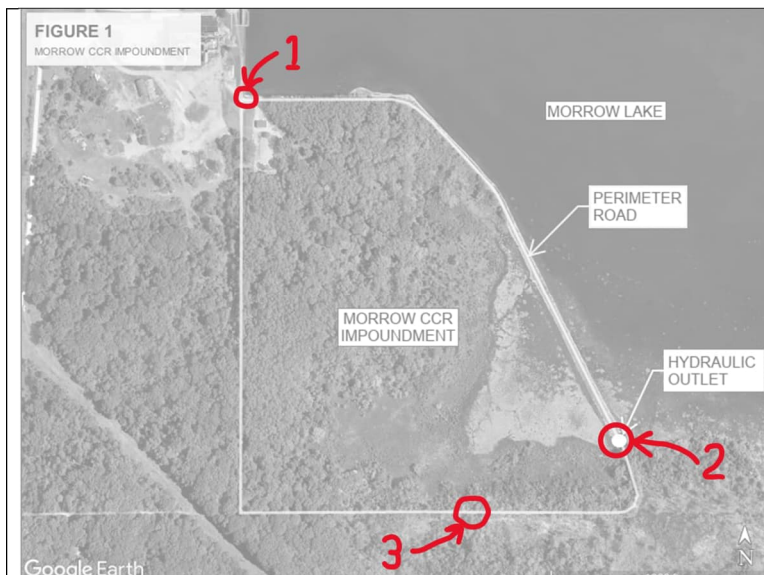
1. Soil covering riprap on outboard slope in NW corner
2. Hydraulic Outlet: buildup of vegetative debris around trash guard/riser structure and in outlet channel to lake and deteriorating concrete along slope between structure and perimeter road.
3. Water observed flowing across the perimeter road and into the CCR Unit.

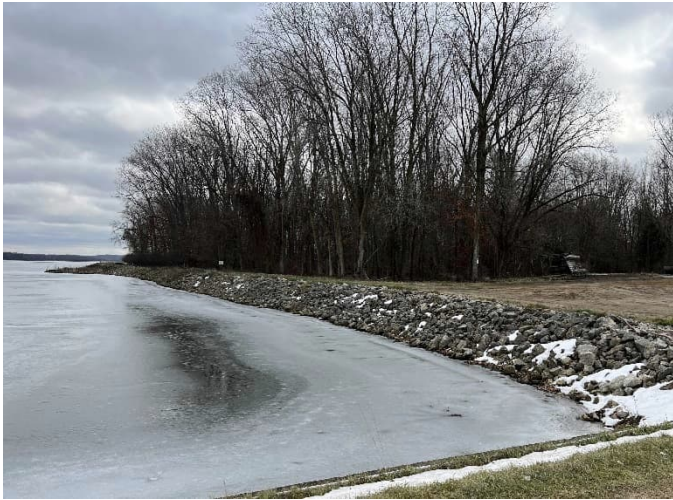
**Photo 1:** Northern perimeter outboard slope looking ESE.

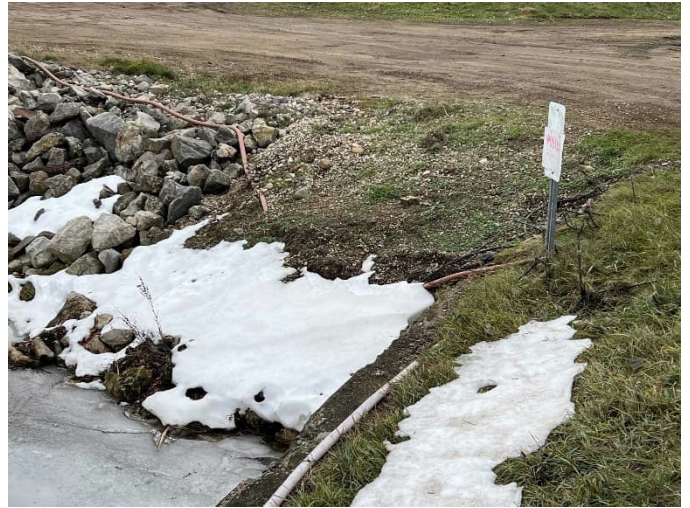
**Photo 2:** Soil covering riprap on outboard slope in NW corner.

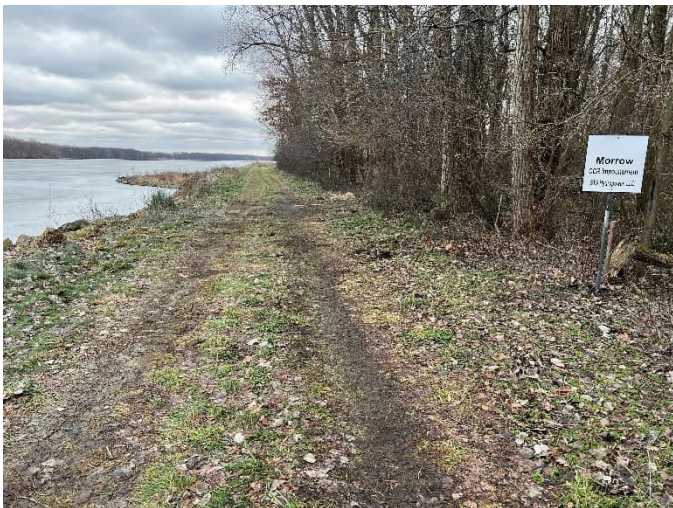
- Several small trees and tall grasses were observed on both the inboard and outboard slopes of the perimeter dike along the north and east sides of the CCR Unit where bordering open water (see Photos 3-5). While not a significant concern at present, the trees should be cut down to prevent potential future issues caused by large/woody root systems and the grasses should be mowed somewhat regularly to allow better inspection of the slopes.

**Photo 3:** Road along northern perimeter looking E. Tall grass on outboard slopes (left side).

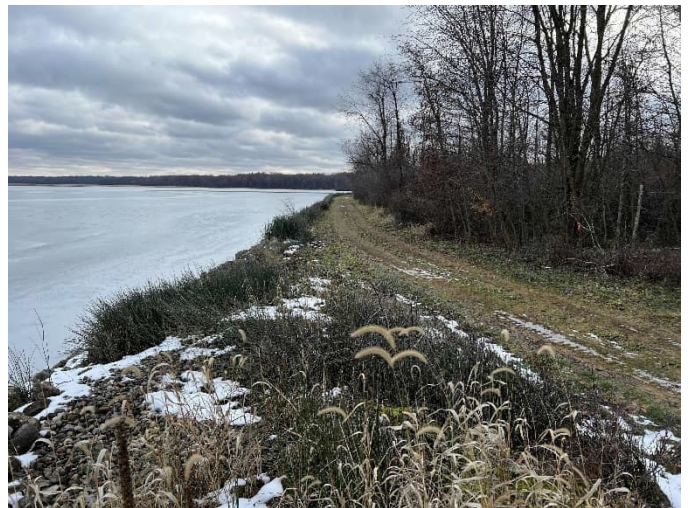
**Photo 4:** Road along northeast perimeter looking SE. Tall grass on outboard slopes (left side).

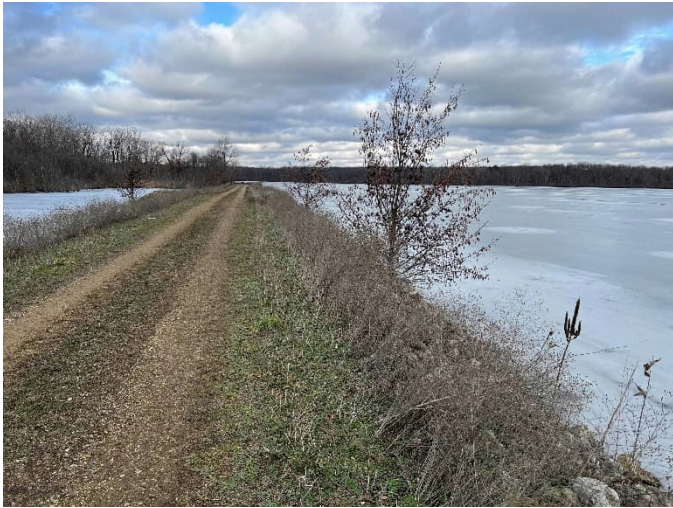
**Photo 5:** Road along eastern perimeter looking NNW. Several typical small trees and tall grass on slopes visible.

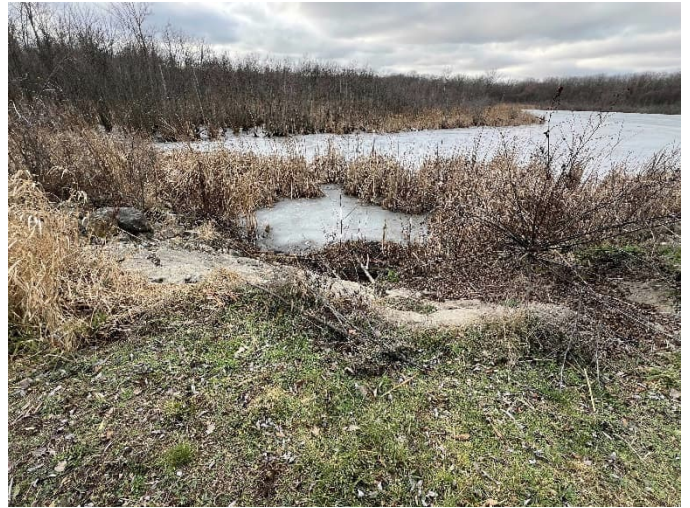
1. Water levels between the CCR Unit and Morrow Lake are in relative equilibrium with little to no flow observed passing through the outlet structure. This is understood to be the normal condition.
2. Debris buildup (see Figure 1 and Photos 6-7 and 9) at both the inlet and outlet ends of the outlet structure should be cleared regularly to remove obstructions to flow and allow for better inspections.

**Photo 6:** Inlet end of hydraulic outlet looking W towards CCR Unit from perimeter road.

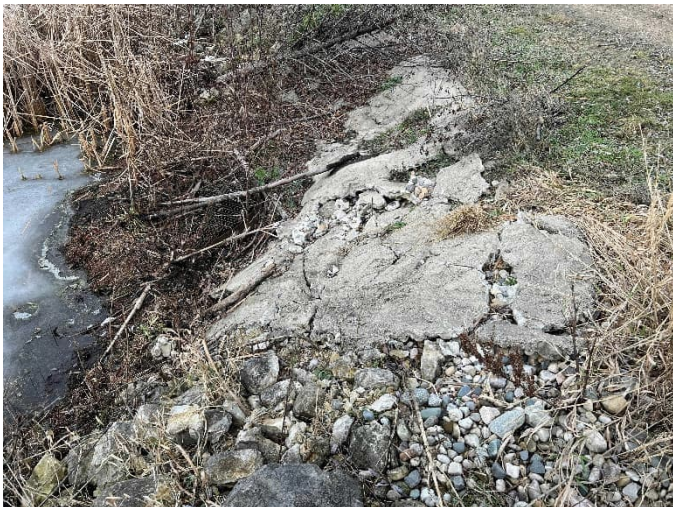
- Deteriorating/cracking concrete (see Figure 1 and Photo 7) along inboard slope adjacent to the outlet structure does not appear to pose any immediate issue, however this area should continue to be monitored.

**Photo 7:** Inlet end of hydraulic outlet looking N. Buildup of vegetative debris around trash guard/riser structure and deteriorating concrete along slope between structure and perimeter road.

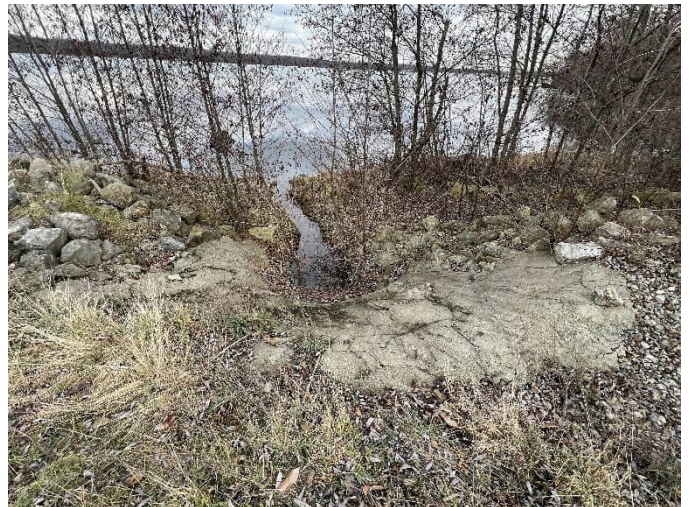
**Photo 8:** Outlet end of hydraulic outlet looking E towards Morrow Lake from perimeter road.

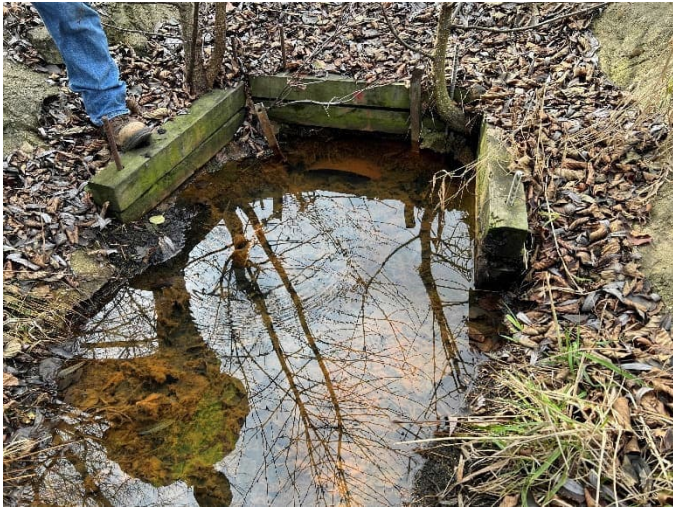
**Photo 9:** Outlet end of hydraulic outlet. No observable flow. Crown of pipe visible, submerged under lake water level. Debris buildup visible under water in channel from pipe to lake.

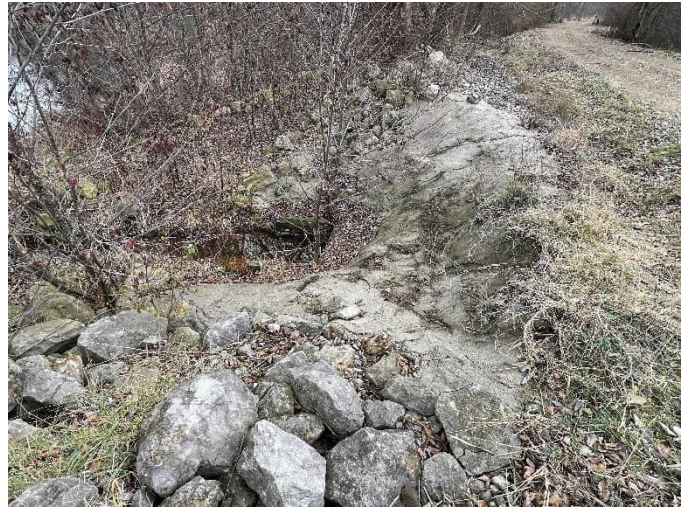
**Photo 10:** Outlet end of hydraulic outlet looking S. Riprap and concrete slope protection in fair condition.

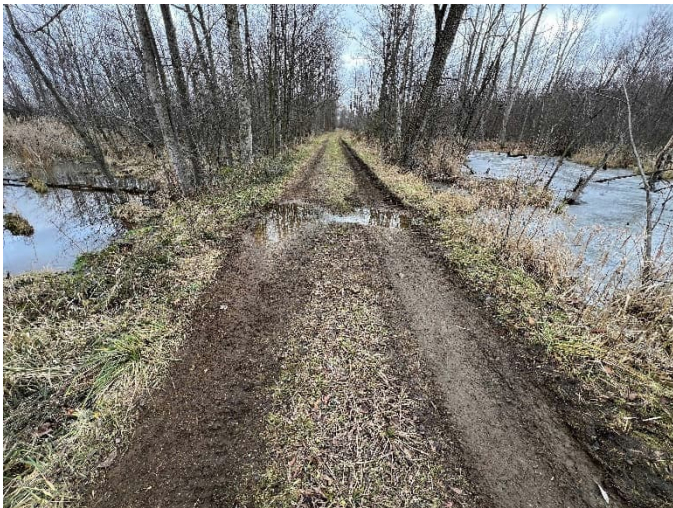
- Wetness observed throughout the site due to it being wet season and recent wet weather, however noted one specific location (see Figure 1 and Photo 11) where water was observed flowing across the perimeter road from a swampy area (south) and into the CCR Unit (north). Some channelization observed but no significant erosion otherwise. Continue to observe and consider future project, however no action recommended at this time.

- Depressions/ruts (see Photos 11-12) caused by vehicle tire tracks in multiple locations around perimeter, particularly along south and west perimeter, and by water flowing across road as noted above, the latter may also be a result of animal activity. Periodic maintenance of roadway recommended.

**Photo 11:** Road along southern perimeter looking E. Water flowing across road from south (right) to north (left). Vehicular rutting visible.

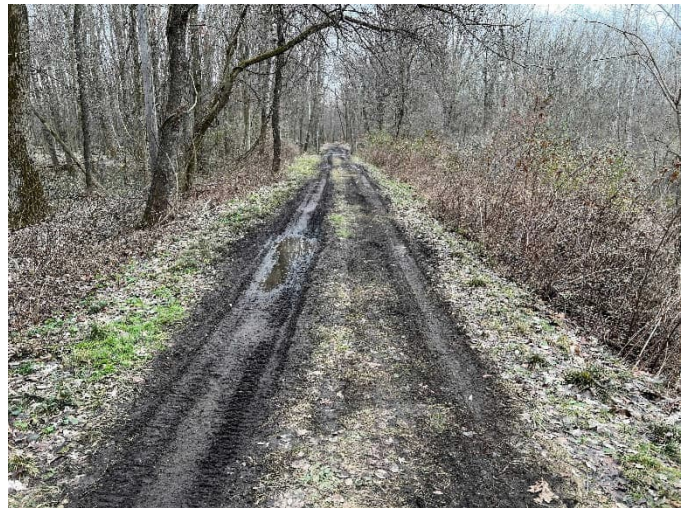
**Photo 12:** Road along western perimeter looking S. Vehicular rutting visible.
