CCR Rule 2025 Annual Inspection Report

Morrow Hydroelectric Project Morrow CCR Impoundment STS Hydropower, LLC

40 CFR 257.83 (b)

February 6, 2026

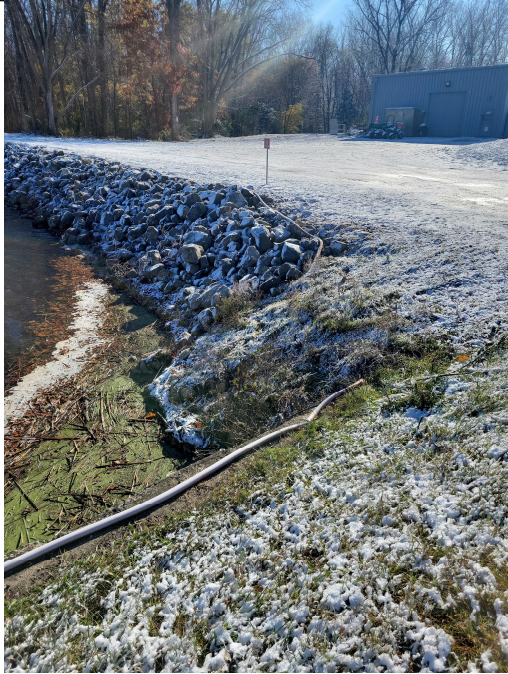
Photo 1: Soil covering riprap on outboard slope in NW corner.

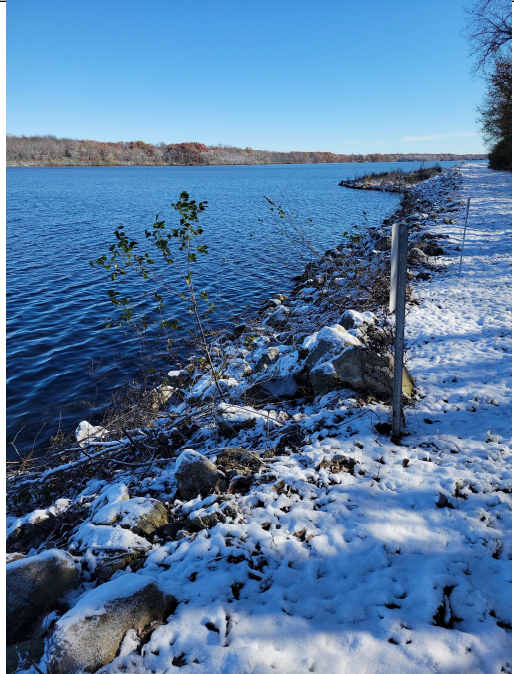
1. A number of small trees and shrubs were observed on both the inboard and outboard slopes of the perimeter dike along the north and east sides of the CCR Unit bordering open water (see Photos 2-5). While not a significant concern at present, the trees should be cut down to prevent potential future issues caused by large/woody root systems and any grasses/reeds growing on slopes should continue to be maintained somewhat regularly to allow better inspection of the slopes.

Photo 2: Road and outboard slope along north perimeter looking east. Vegetation on outboard slope.

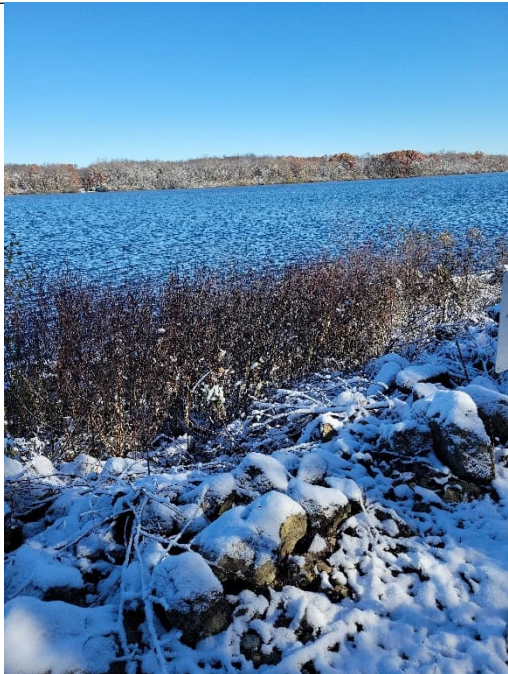
Photo 3: Patch of tall grasses/reeds along outboard slope of northern perimeter looking northeast.

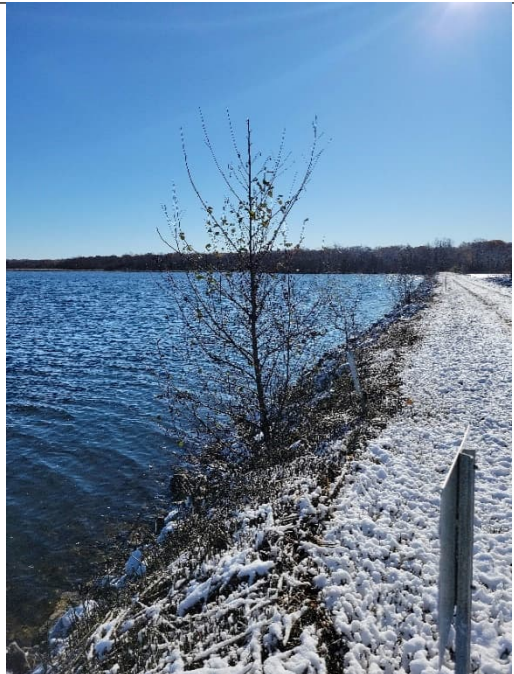
Photo 4: Road along east perimeter looking Southeast. Tall tree/shrub on outboard slope.

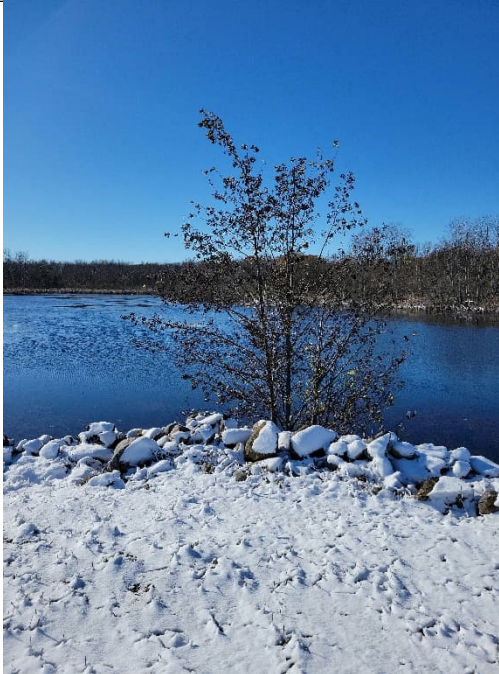
Photo 5: Road along eastern perimeter looking SW. Tall shrub/tree on inboard slope.

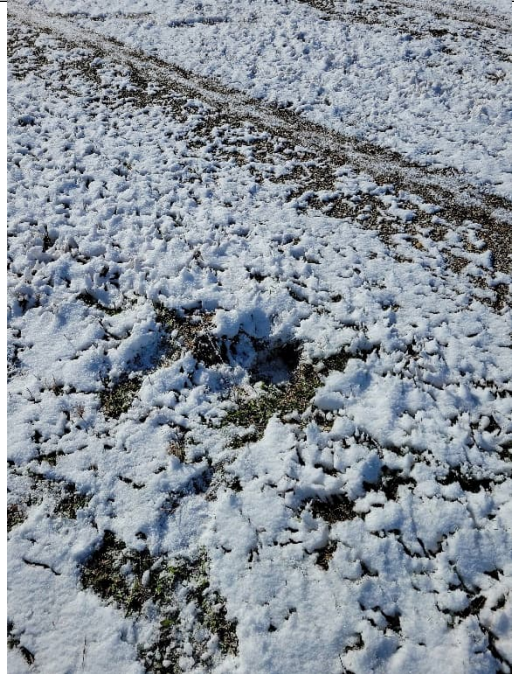
Photo 6: Animal burrow located on crest of dike near hydraulic outlet.

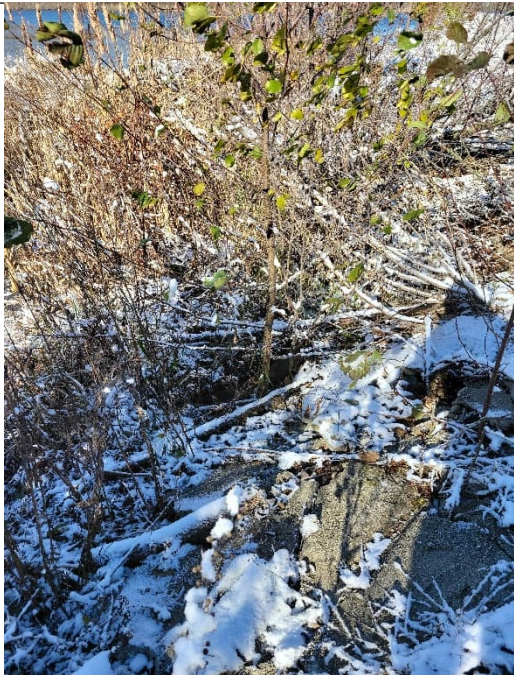
4. Deteriorating/cracking concrete (see Figure 1 and Photo 7) along inboard slope adjacent to the outlet structure does not appear to pose any immediate issue, however this area should continue to be monitored.

1. Water levels between the CCR Unit and Morrow Lake are in relative equilibrium with little to no flow observed passing through the outlet structure. This is understood to be the normal condition.
2. Debris buildup (see Figure 1 and Photos 7, 8, and 9) at both the inlet and outlet ends of the outlet structure should be cleared regularly to remove obstructions to flow and allow for better inspections.

Photo 7: Inlet end of hydraulic outlet looking NW. Buildup of vegetative debris around trash guard/riser structure and deteriorating concrete along slope between structure and perimeter road.

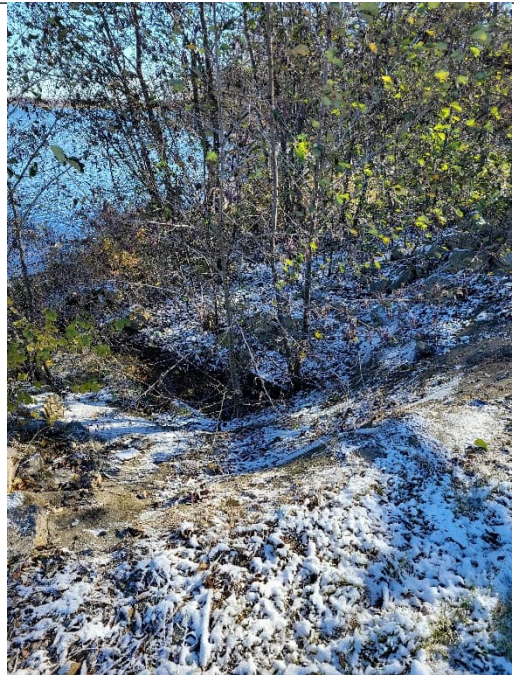
Photo 8: Outlet end of hydraulic outlet looking E towards Morrow Lake from perimeter road. Riprap and concrete protection in fair condition.

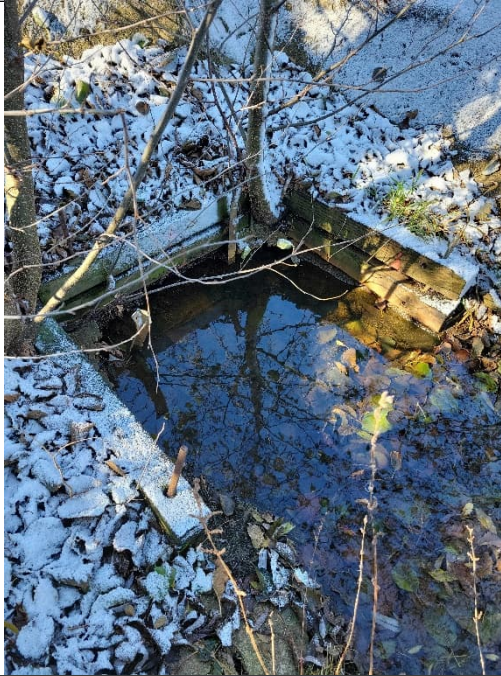
Photo 9: Outlet end of hydraulic outlet. No observable flow. Crown of pipe visible, submerged under lake water level. Debris buildup visible under water in channel from pipe to lake.

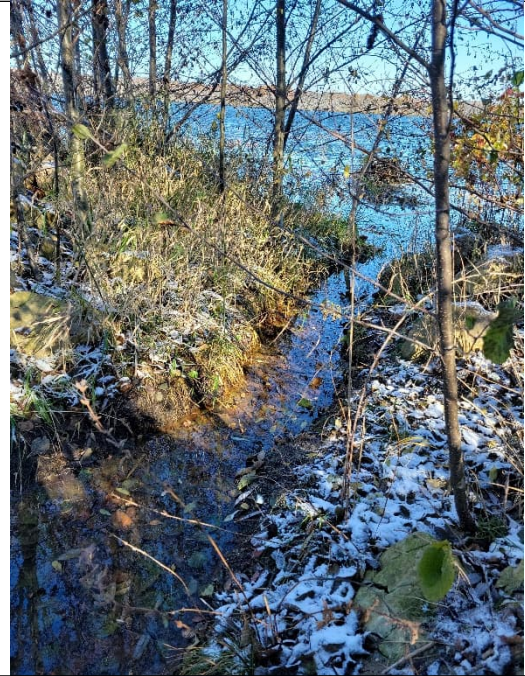
Photo 10: Channel from end of hydraulic outlet to Morrow Lake. No observable flow.

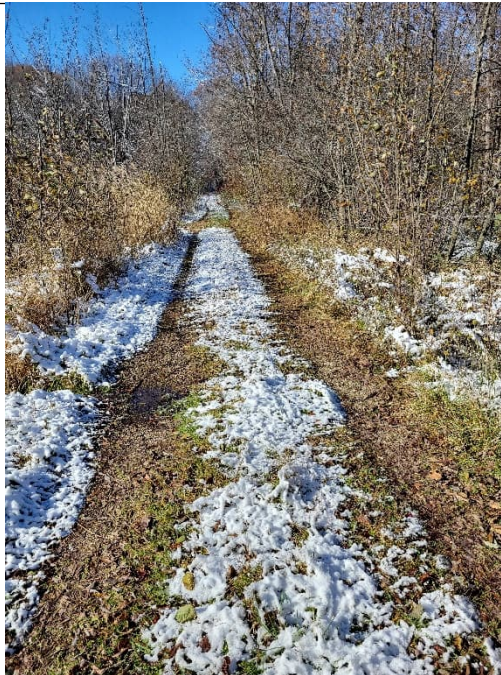
2. Wetness observed throughout the site due to it being wet season and recent wet/snowy weather, however noted one specific location (see Figure 1 and Photo 11) where water was observed ponding on perimeter road. This implies the possibility of water to flow across the perimeter road from a swampy area (south) into the CCR Unit (north) under suitable conditions. Some channelization observed but no significant erosion otherwise. Continue to observe and consider future repair project, however no action recommended at this time.

3. Depressions/ruts (see Photos 11-12) caused by vehicle tire tracks in multiple locations around perimeter, particularly along south and west perimeter, and by water flowing across road as noted above, the latter may also be a result of animal activity. Periodic maintenance of roadway recommended.

Photo 11: Road along southern perimeter looking W. Water ponding on road, indicative of flow from south (left) to north (right). Vehicular rutting visible.

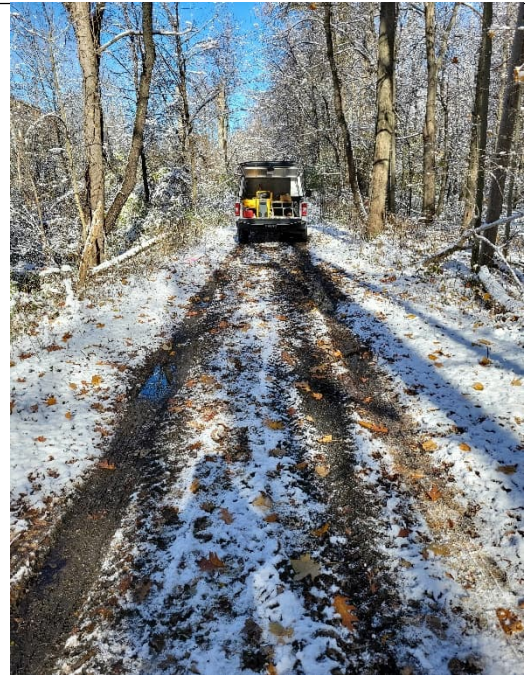
Photo 12: Road along western perimeter looking N. Vehicular rutting visible.
