# **CCR Rule 2025 Annual Inspection Report**

## **Morrow CCR Impoundment STS Hydropower, LLC**

**February 6, 2025**

**Attachment:**  
**STS Morrow CCR Impoundment – Annual Inspection Form**

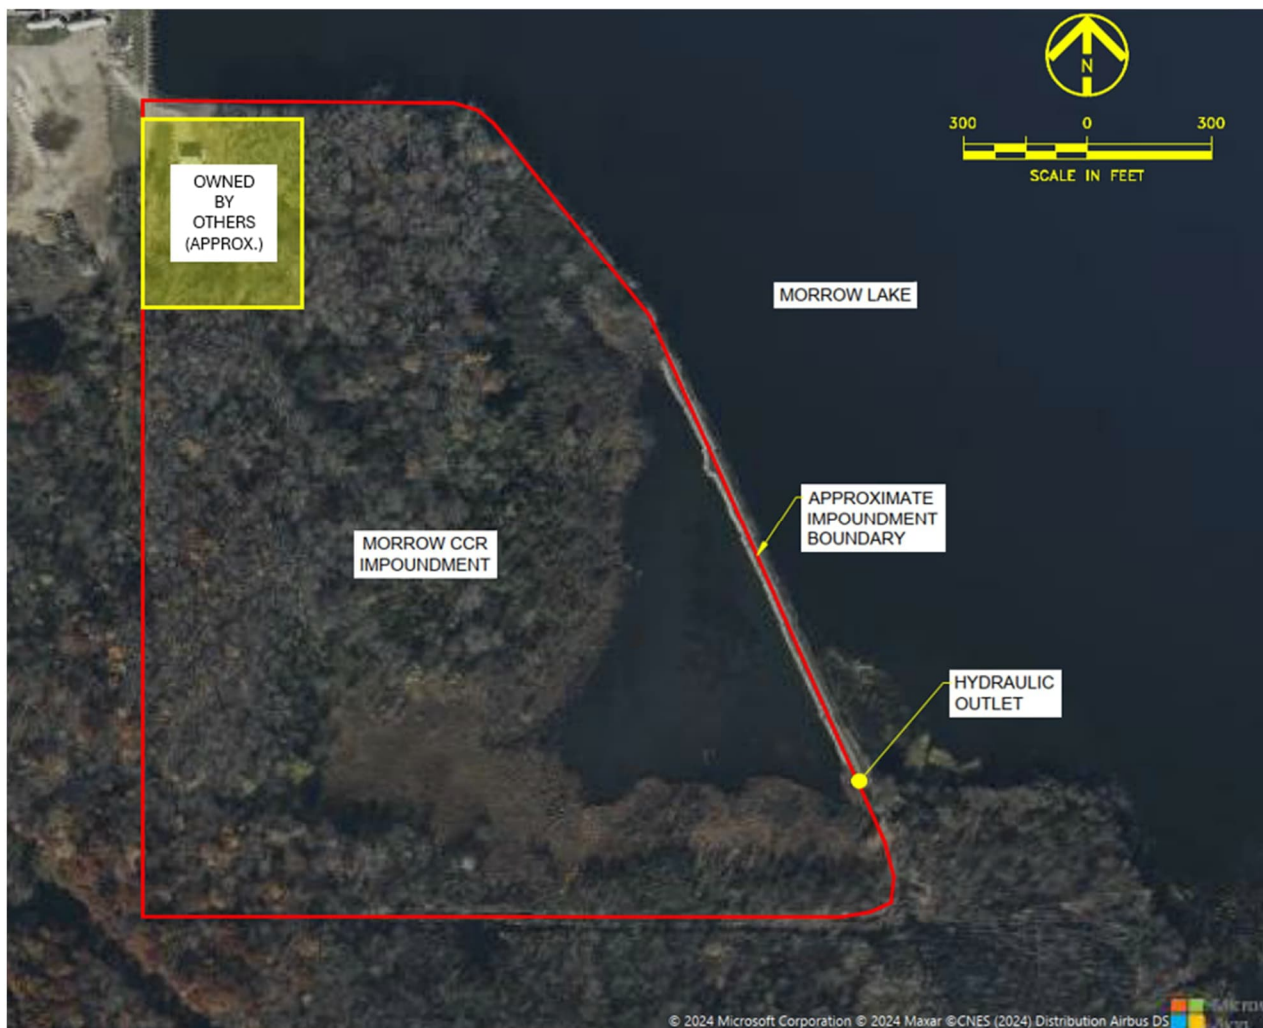
**Figure 1 – Morrow CCR Impoundment**

- Wetness observed throughout the site due to it being wet season and recent wet weather, however noted one specific location (see Figure 1 and Photo 11) where water was observed flowing across the perimeter road from a swampy area (south) and into the CCR Unit (north). Some channelization observed but no significant erosion otherwise. Continue to observe and consider future project, however no action recommended at this time.

- Deteriorating/cracking concrete (see Figure 1 and Photo 7) along inboard slope adjacent to the outlet structure does not appear to pose any immediate issue, however this area should continue to be monitored.
