CCR Rule 2025 Annual Inspection Report

Morrow Hydroelectric Project Morrow CCR Impoundment STS Hydropower, LLC

40 CFR 257.83 (b)

February 6, 2026

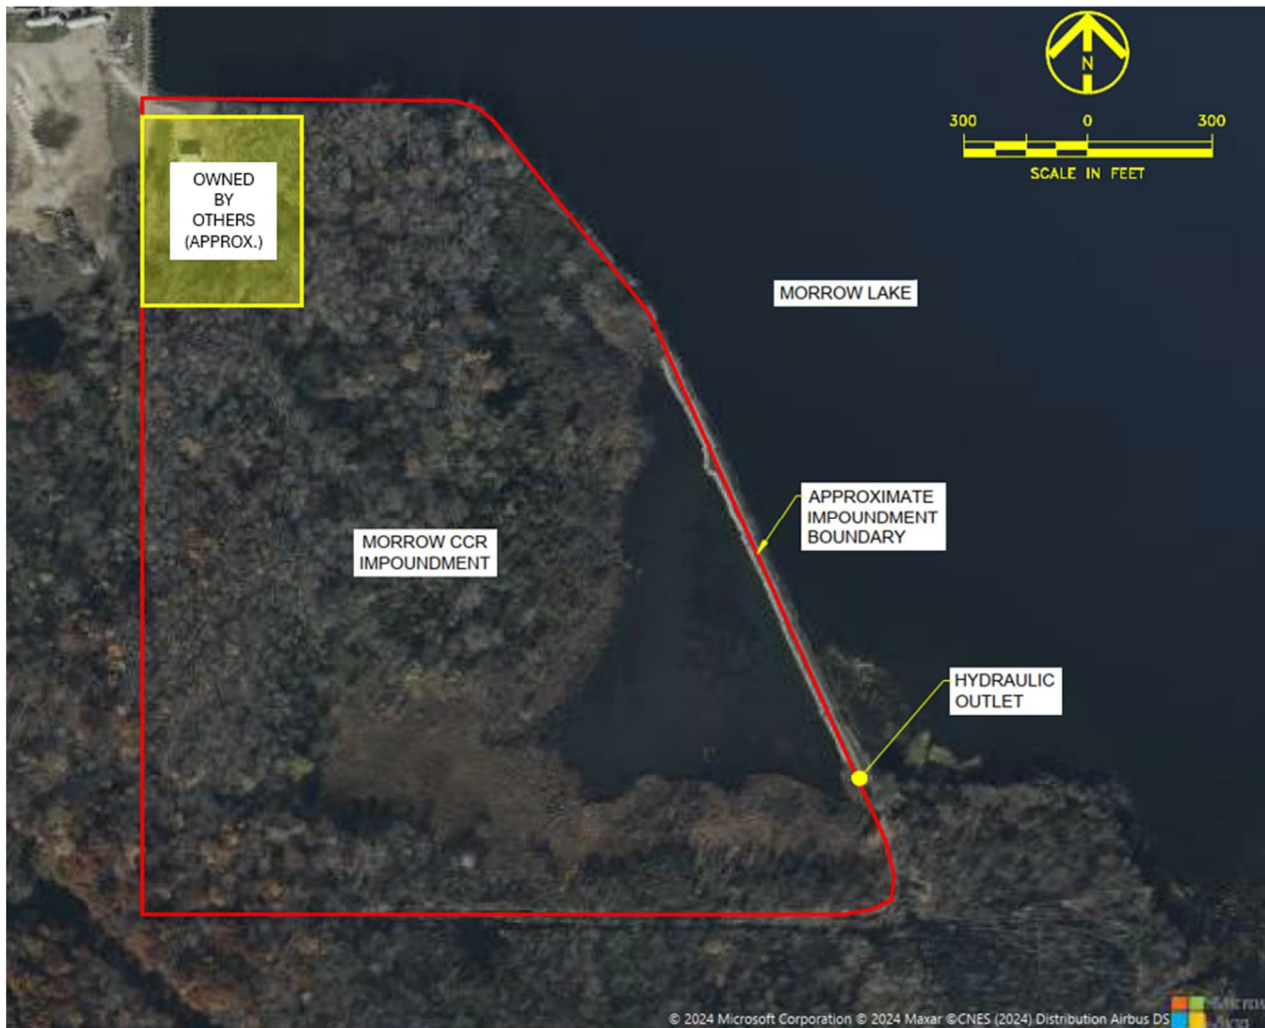
Figure 1 – Morrow CCR Impoundment

2. Wetness observed throughout the site due to it being wet season and recent wet/snowy weather, however noted one specific location (see Figure 1 and Photo 11) where water was observed ponding on perimeter road. This implies the possibility of water to flow across the perimeter road from a swampy area (south) into the CCR Unit (north) under suitable conditions. Some channelization observed but no significant erosion otherwise. Continue to observe and consider future repair project, however no action recommended at this time.

4. Deteriorating/cracking concrete (see Figure 1 and Photo 7) along inboard slope adjacent to the outlet structure does not appear to pose any immediate issue, however this area should continue to be monitored.
